**Controlled flight into terrain
11 km south-east of Kokoda Airstrip
Papua New Guinea
11 August 2009
P2-MCB
De Havilland Canada DHC-6-300**

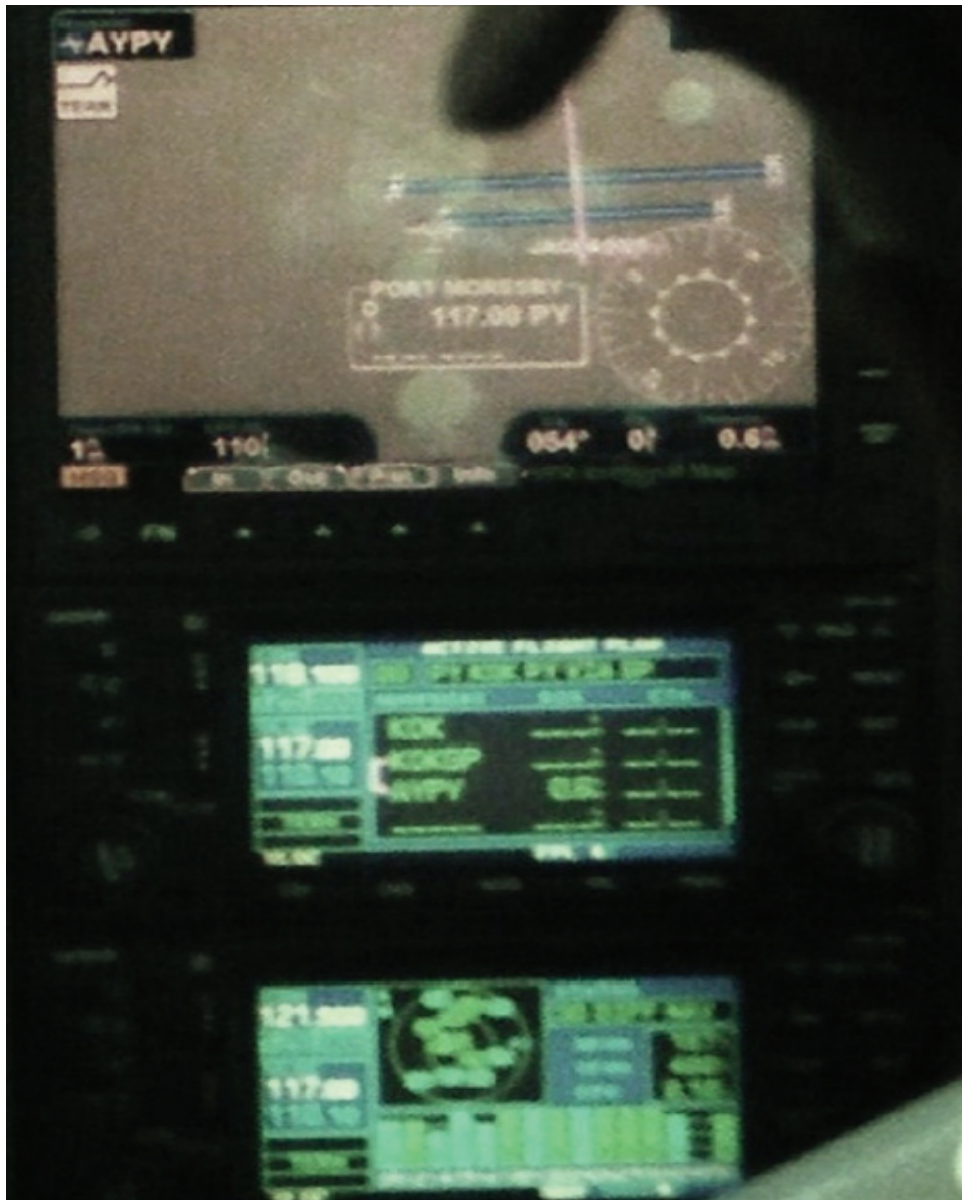
Figure 4: Photograph of the aircraft's GMX200 and GNS430 prior to departure from Jackson's International Airport¹¹

Figure 4 is a photograph of the aircraft's GNS430 and GMX200 prior to departing Jackson's International Airport, Port Moresby for Kokoda. The displays in the photograph show the information that was displayed to the flight crew at departure,

- (1) GMX200 showing a GPS image of Jackson's Aerodrome (AYPY) and the aircraft's current position.
- (2) GNX430 showing the primary and secondary radio frequency set for communication 1 and the intended route to Kokoda (KOK) via the Kokoda Gap (KOKGP) to Jackson's aerodrome (AYPY)
- (3) GNX430 showing the primary and secondary radio frequency set for communication 2 and the available satellites at the time.

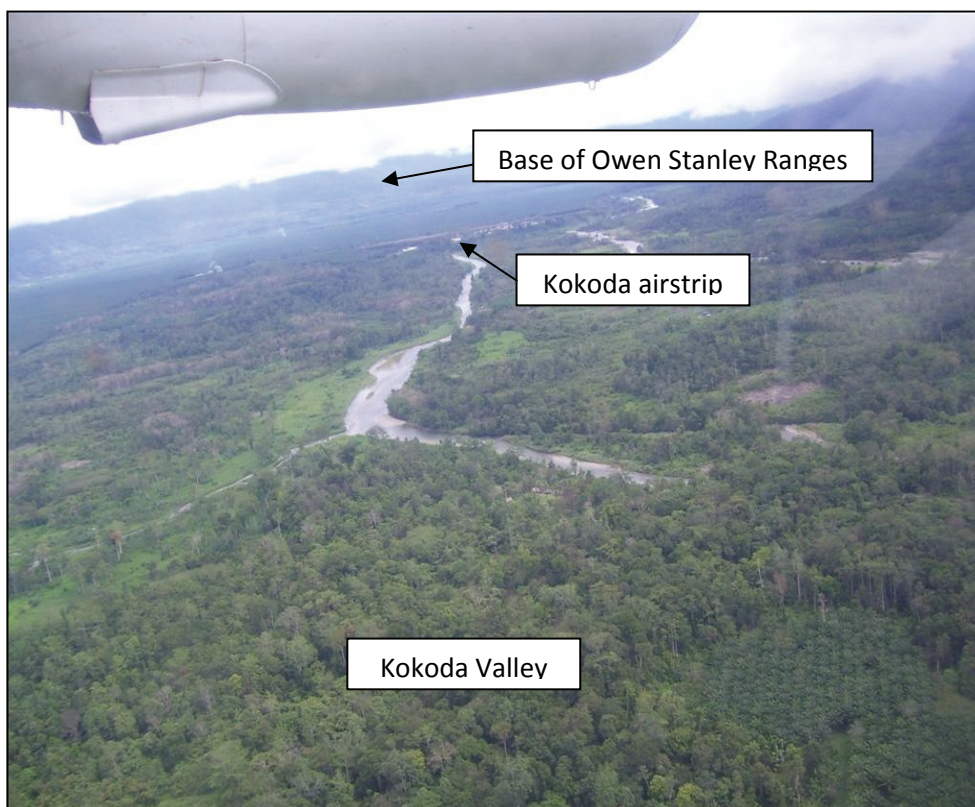
Figure 5: Kokoda Valley about 30 minutes before the estimated time of the accident

A photo taken by a passenger in another aircraft flying to Kokoda Airstrip about 30 minutes before the estimated time of the accident, showed that the Kokoda Valley was clear of cloud at that time (Figure 5).

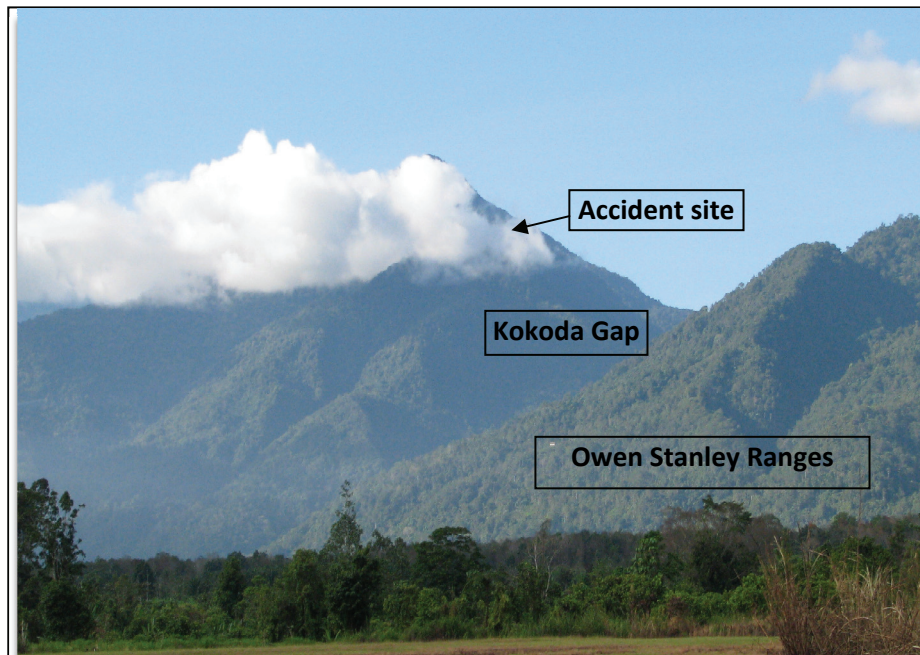
Figure 7: View from Kokoda airstrip showing the Kokoda Gap on a good weather day

At about 1115, the Kokoda agent telephoned the operator's operation's centre and advised staff that 'the weather was very bad [at Kokoda].' A photo that was taken at Kokoda Airstrip looking toward the Kokoda Gap at about the time of the accident showed the Kokoda Gap completely obscured by cloud (Figure 6). A comparative photograph of the Kokoda Gap on a good weather day is at Figure 7.

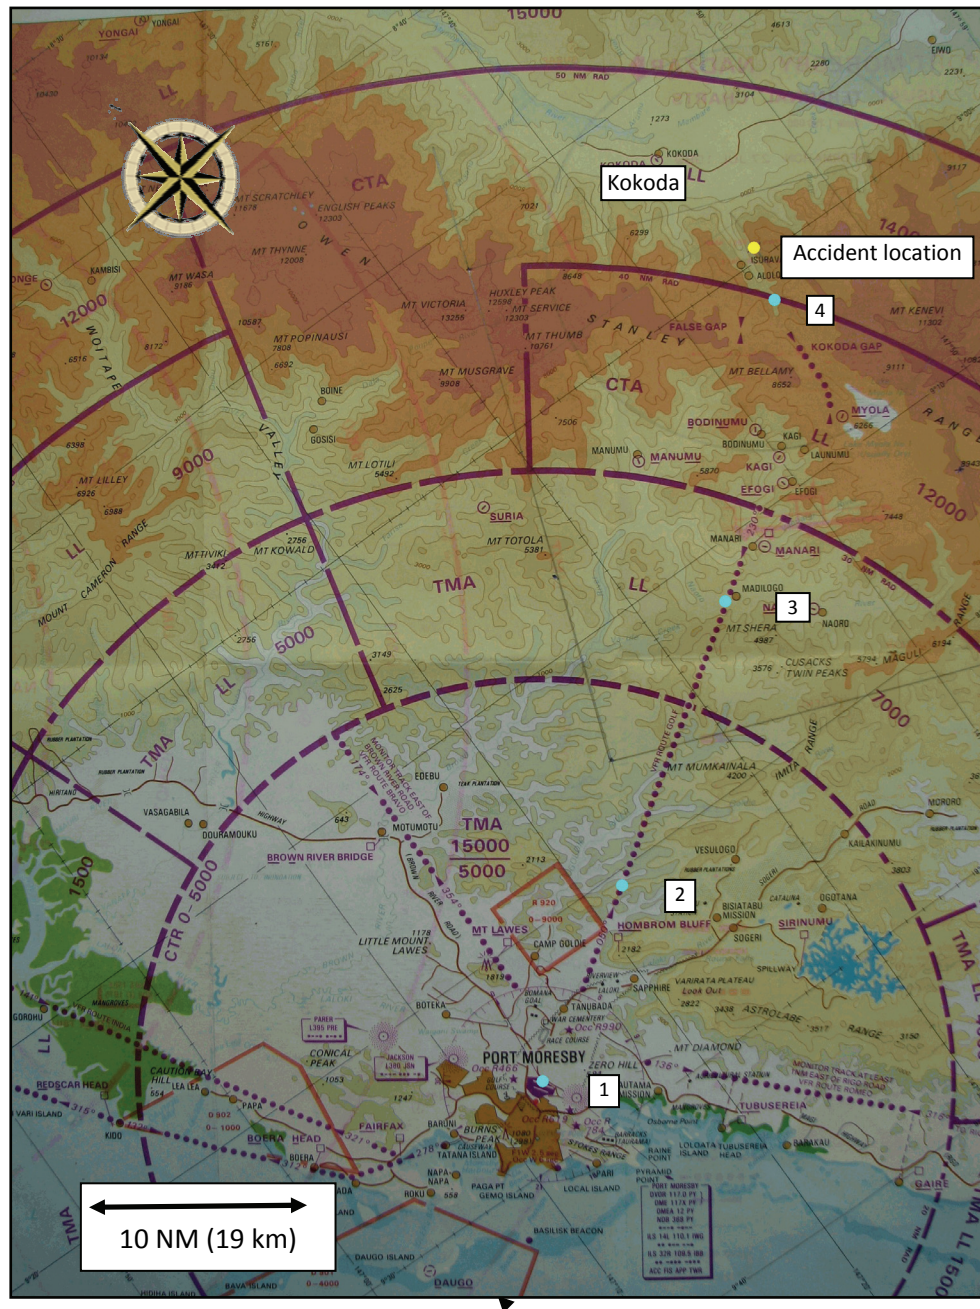
Figure 8: Port Moresby Visual Terminal Chart overlaid with the aircraft's S100-derived positions during the flight

The data that was recovered from the S100 showed the aircraft departing Jackson's International Airport Port Moresby at 1052 (Table 6) and that there were three other S100 recordings during the flight (highlighted blue in Figure 8). Those recordings showed the aircraft's track to Kokoda Gap at a maximum recorded altitude of 9,742 ft. That was consistent with the crew's radio communications with Port Moresby ATC.

Recording	Time	Latitude (°S)	Longitude (°E)	Speed (kts)	Heading (° True)	Altitude (ft)
1	1052:32	9° 26.20'	147° 12.85'	60	148°	122'
2	1059:20	9° 20.73'	147° 21.65'	110	056°	6,976'
3	1106:07	9° 12.31'	147° 33.87'	154	054°	9,742'
4	1112:46	9° 01.69'	147° 44.49'	127	002°	8,079'
